Ionizing Radiation Test Report for FCF Hardware tested March 2003 (and September 2003 and March 2004)

Fluids and Combustion Facility (FCF)

Rev. A
Final
April 1, 2004

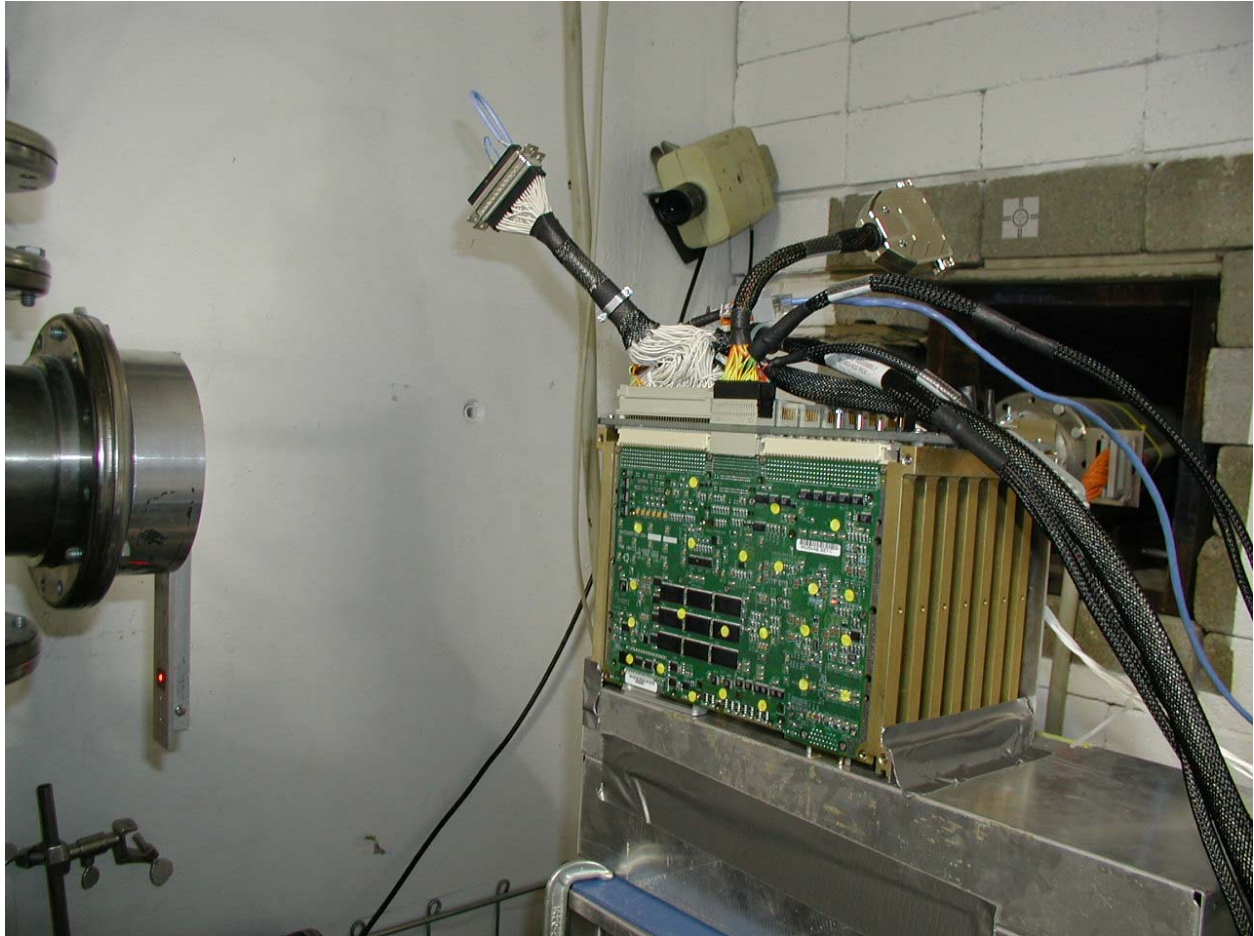
FIGURE 1. DY-4 SVME179-1440 Single Board Computer and DY-4 Dual Channel 1553B PMC601 Board (tested simultaneously)

The errors that were encountered while testing the I/OP/FCU DY-4 SVME179-1440 Single Board Computer and the I/OP DY-4 Dual Channel 1553B PMC-601 Board, produced an overall MTBF of 16.4 days. These errors consisted of functional interrupts and data corruption errors. In most instances a recycling of power to the Single Board Computer was needed to correct the error.

When the I/OP Main Processor (DY-4 Single Board Computer) sees a non-destructive ionizing radiation event that precludes the “heart-beat” signal from being received by the I/OP CANbus Processor (3 consecutively missed signals), the CANbus Processor will try to reboot the Main Processor. This problem will be recognized by ISS and ground personnel because of the loss of required health and status data. Ground personnel will have to perform some level of root cause analysis to determine the cause of this lost data, and will take appropriate actions to reinitialize the I/OP for proper operations. All I/OP attributes will be re-verified prior to experiment progressions starting or continuing.

When the I/OP High Rate Data Link (HRDL) Processor (DY-4 Single Board Computer) sees a non-destructive ionizing radiation event that precludes the HRDL signal from being received by ISS or ground personnel, ground personnel will have to take action. At this point ground personnel will command the I/OP to cycle power to the I/OP HRDL Processor in an attempt to restore I/OP HRDL Processor functionality. If I/OP HRDL Processor functionality is not restored, ground personnel will have to perform some level of root cause analysis to determine the cause of this lost signal. Experiment progression can continue if downlink capability through the HRDL is not mandatory for experiment success. If power cycling restores I/OP HRDL Processor functionality, all I/OP attributes will be re-verified prior to experiment progressions starting or continuing.

When the FCU Single Board Computer sees a non-destructive ionizing radiation event that precludes the health and status signal from being received by the I/OP (3 consecutively missed signals), the I/OP will power down the FCU, will place all packages into an “idle mode”, will place all FOMA hardware into a “safe-mode”, and report the loss of this health and status signal to ground personnel. Ground personnel will have to perform some level of root cause analysis to determine the cause of this lost signal, and will take appropriate actions (i.e. cycle power to the FCU) to reinitialize the FCU for proper operations. All FCU attributes will be re-verified prior to experiment progressions starting or continuing.

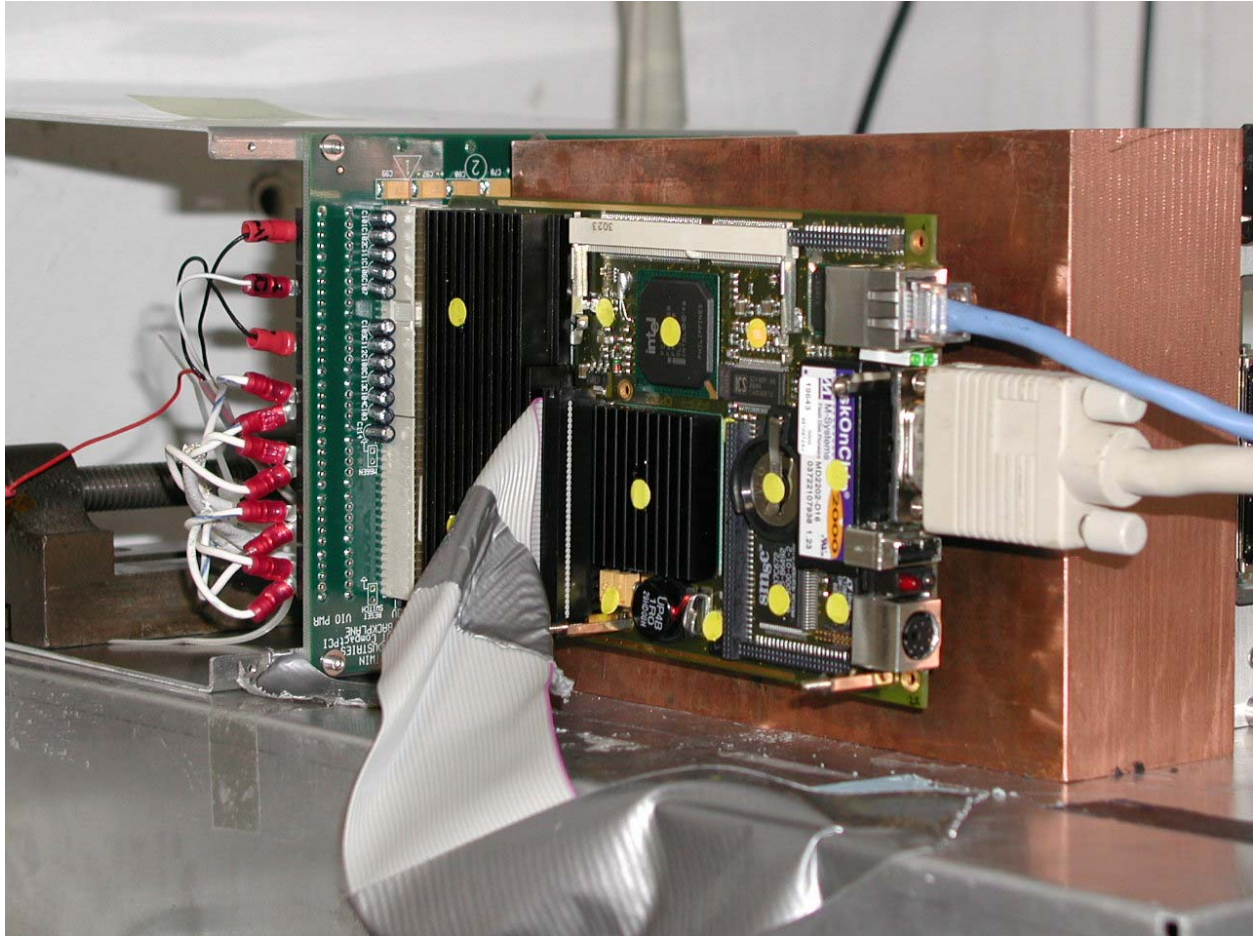
FIGURE 2. PEP CP302 Single Board Computer

The errors that were encountered while testing the IPSU/FSAP PEP CP-302 Single Board Computer produced an overall MTBF of **15.3** days. These errors consisted of functional interrupts and data corruption errors. In most instances a recycling of power to the Single Board Computer was needed to correct the error.

A second PEP CP-302 Single Board Computer was tested which produced a destructive event MTBF of 1,450 days. Root cause analysis performed by PEP/Kontron produced the following results as reported from PEP/Kontron:

We determined that IC18 on the CP302-Baseboard failed (see attached, p2). This is the Altera EPM7128STC100-15 PLD (<http://www.altera.com/literature/ds/m7000.pdf>). The failure was due to overvoltage being applied to the PLD. Overvoltage is a general term we use to describe a chip that's fried. I can look into possible board-related causes, but given the nature of your testing, I don't know if that would help you any.

The Altera IC referenced above was being exposed to ionizing radiation when the destructive event occurred.

No additional testing of the PEP/Kontron CP-302 Single Board Computer is planned as the destructive event had a relatively large MTBF at a 100% duty cycle. This MTBF will on average double as duty cycles are accounted for.

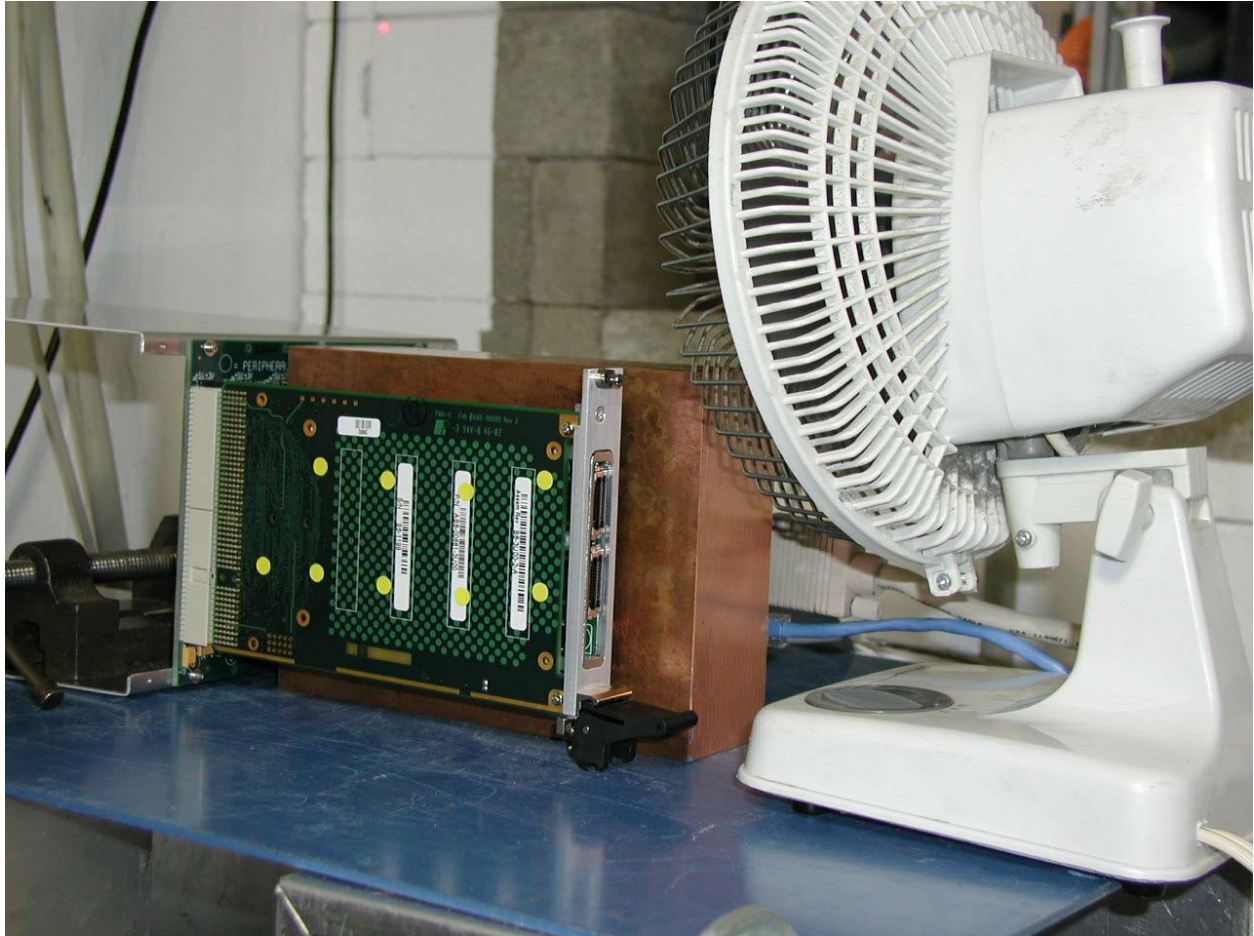
FIGURE 3. Bittware Quad 21160 Sharc DSP Board

The errors that were encountered while testing the IPSU Bittware DSP Sharc Board produced a destructive event MTBF of 319 days and 1,440 days. These errors were fully destructive, and the two MTBF values presented above were for one unique position on each of the two distinct boards that were tested. Therefore the MTBFs presented above only represent the failure rates for the components within the unique zones in question, and by no means reflect the entire boards total MTBF. Additional testing is planned for this board, and will be added to this test report accordingly.

Both units were verified to have non-functional DSP chips (even though the DSP chips were not specifically exposed to the direct ionizing radiation beam) when the boards were returned to Bittware for analysis. See additional information as obtained in our September, 2003 testing involving the potential for stray proton effects.

Upon return, DSP Chip # 2 was found to be non-functional.

Upon return, DSP Chip # 3 was found to be non-functional. This is the DSP chip in test position number 7.

An additional estimate was performed to simulate the effect if all four DSP chips on the card were to be exposed and failed in a like duration, resulting in a 1.5 day MTBF just for exposing the four DSP chips to an equivalent dose of ionizing radiation.

A NGIT/NASA committee has been formulated to address mitigation plans for this highly susceptible COTS card.

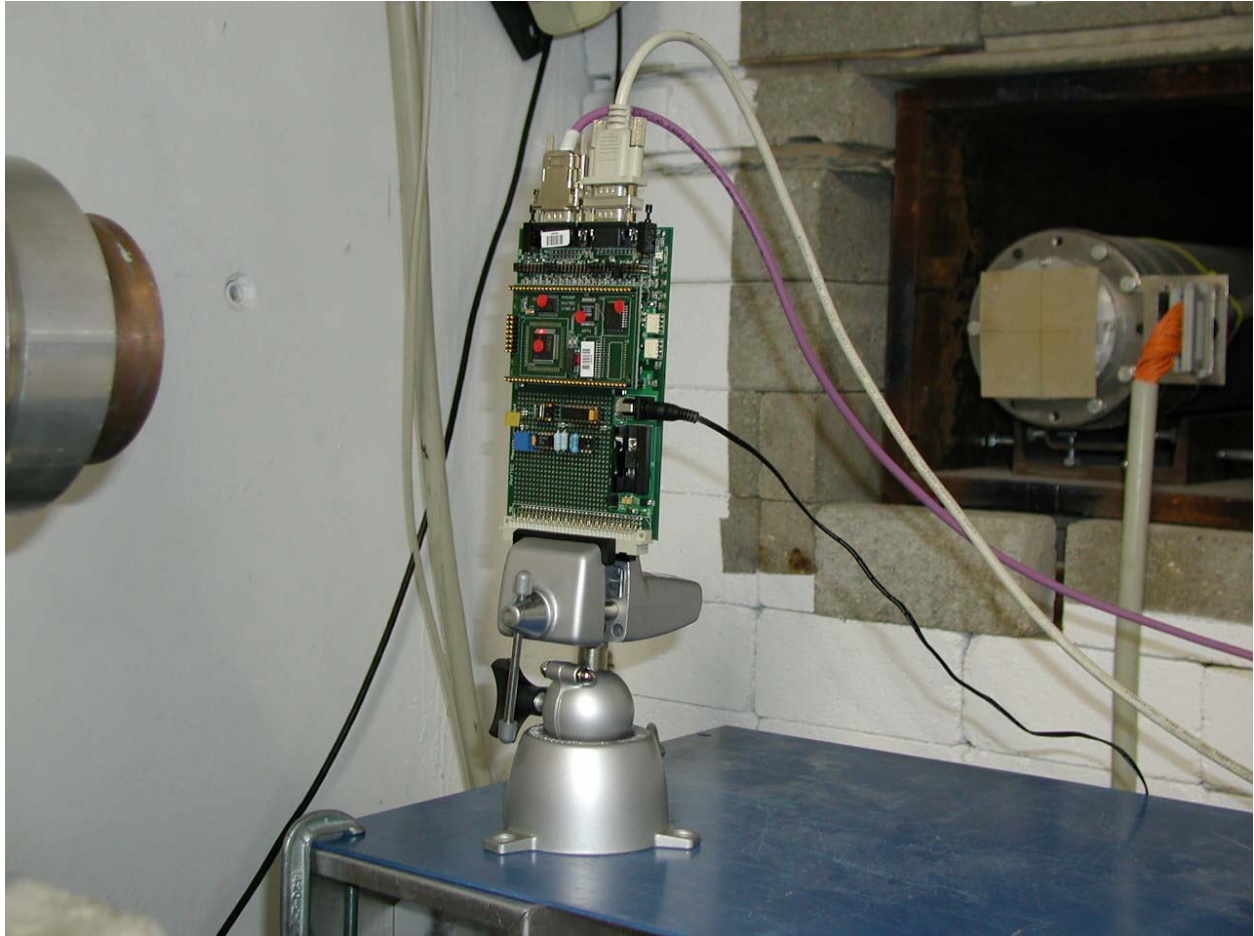
FIGURE 4. Phytel miniMODUL-515 CAN Module

There is no reported impact on the operational availability of the FCF as a result of testing the Phytex mini-MODUL-515-CAN Controller Board. Only one error was encountered producing an overall MTBF of 676 days. The board function auto-corrected itself once the error was flagged therefore leading to the conclusion that this error will have no operational availability impact. Subsequent in-lab testing produced the same type error, indicating that the error observed was most likely not a direct result of exposure to ionizing radiation.

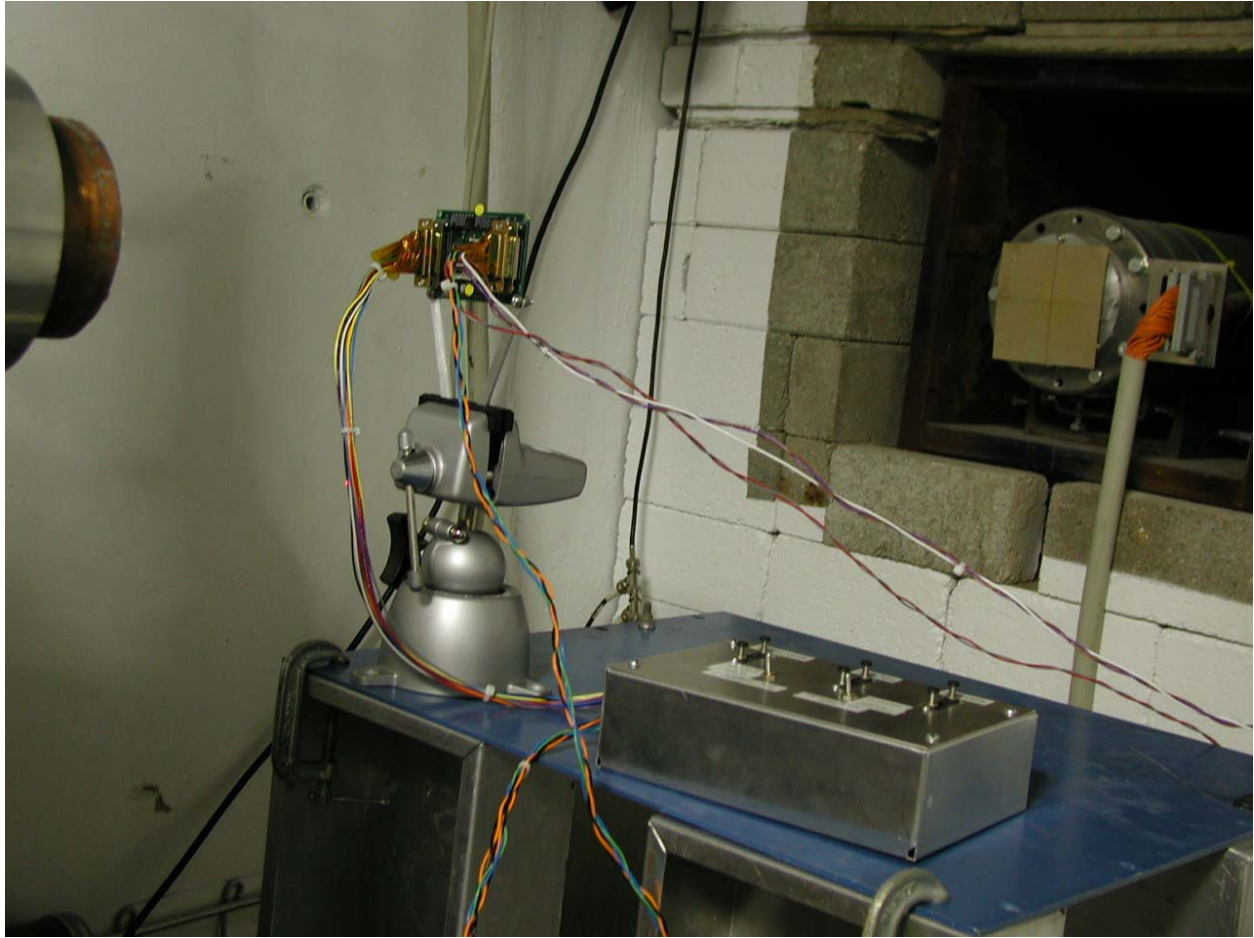
FIGURE 5. Custom Designed FOMA Valve Timer

There is no reported impact on the operational availability of the Custom Designed FOMA Valve Timer and subsequently the FOMA as a result of testing the Custom Designed FOMA Valve Timer. No errors were encountered.

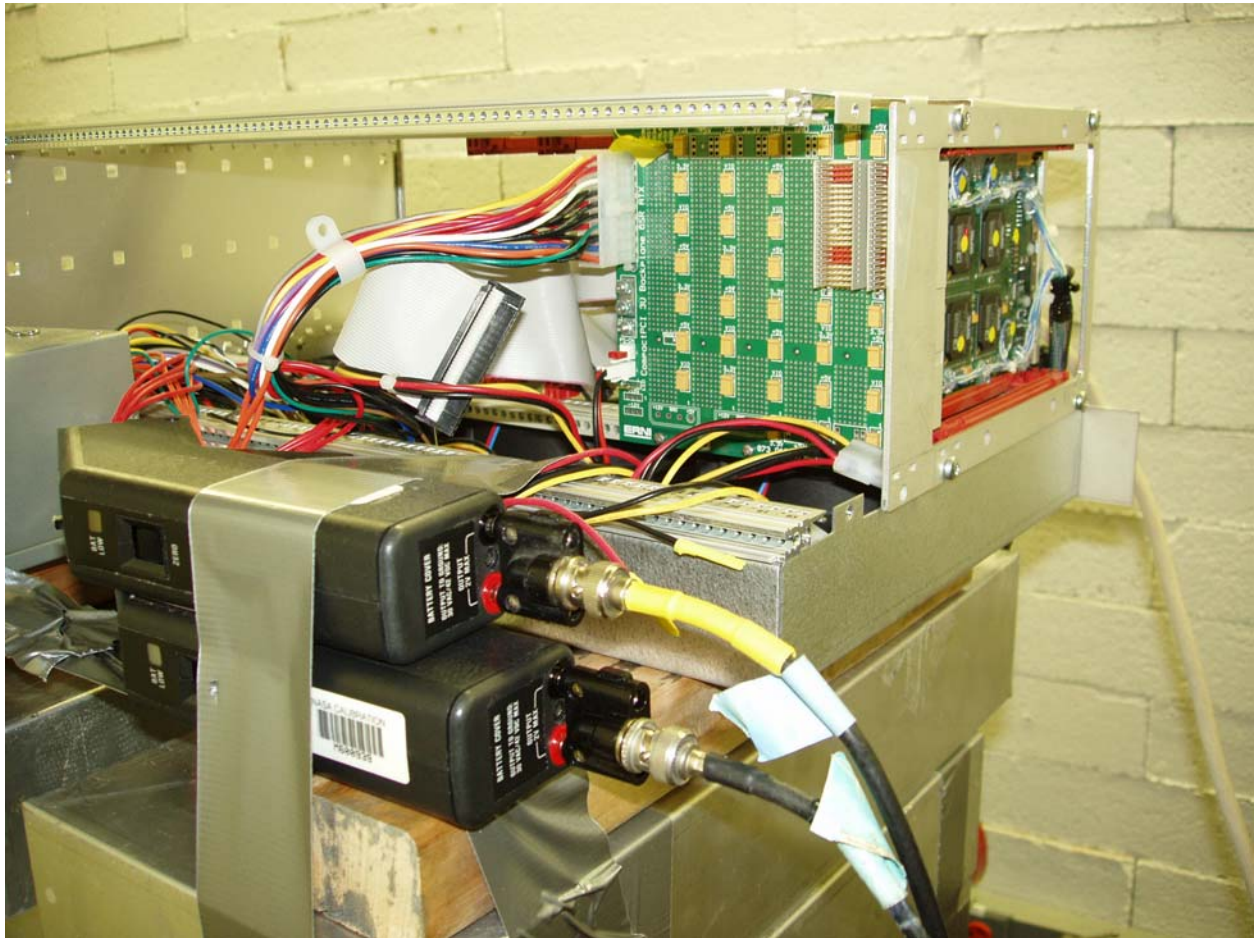
FIGURE 6. Bittware Quad HS3U "Space" DSP Board (prototype)

We began testing by specifically targeting one of the DSP chips, Hammerhead DSP chip #2. The boards were operated in the 7x7 convolution mode for the highest current draw. The current interruption circuitry was operated in "Auto Shutdown mode", the mode they were to operate in flight. Auto shutdown mode also offers the fastest current turn off time. The board experienced a current interrupt very quickly, on the order of 1 to 3 seconds of testing at the lowest fluence rate possible at the IUCF. The board survived about 3 recoverable current trips before experiencing a destructive failure a fluence of < 3% of the intended total dose. The board was analyzed at determined that the V_{Core} power supply for the targeted DSP chip was shorted to ground, ~0.8 Ohms, on the DSP chip in question. The nominal V_{Core} power supply resistance to ground is ~820 Ohms.

We then targeted the current interruption circuitry for Hammerhead DSP #2 on a second board. We obtained similar results; the DSP chips experienced about 3 recoverable current trips before experiencing a destructive failure. The failures were at a higher fluence level, but it was disturbing that the DSP chips were experiencing any effects from the proton beam because they were not being targeted. Again the board was analyzed at determined that the V_{Core} power supply for the targeted DSP chip was shorted to ground, ~0.8 Ohms, on the DSP chip in question.

We then removed the crowbar FETs from the current interruption circuitry and that also had no effect on the board performance. The board survived about 3 recoverable current trips before experiencing a destructive failure. The board was analyzed at determined that the V_{Core} power supply for the targeted DSP chip was shorted to ground, ~0.8 Ohms, on the DSP chip in question.

All of the DSP chip failures were attributed to a short of the V_{Core} power supply to ground. This is consistent with 90% of the DSP chip architecture consisting of hardware being supplied by V_{Core} power.

The 2 damaged boards were taken to PTS Electronics, a board house in Bloomington. They replaced the two damaged DSP chips in a few hours. We tested the boards after they were returned and they were fully functional.

A NGIT/NASA committee is still convening to address mitigation plans for this highly susceptible COTS prototype card.

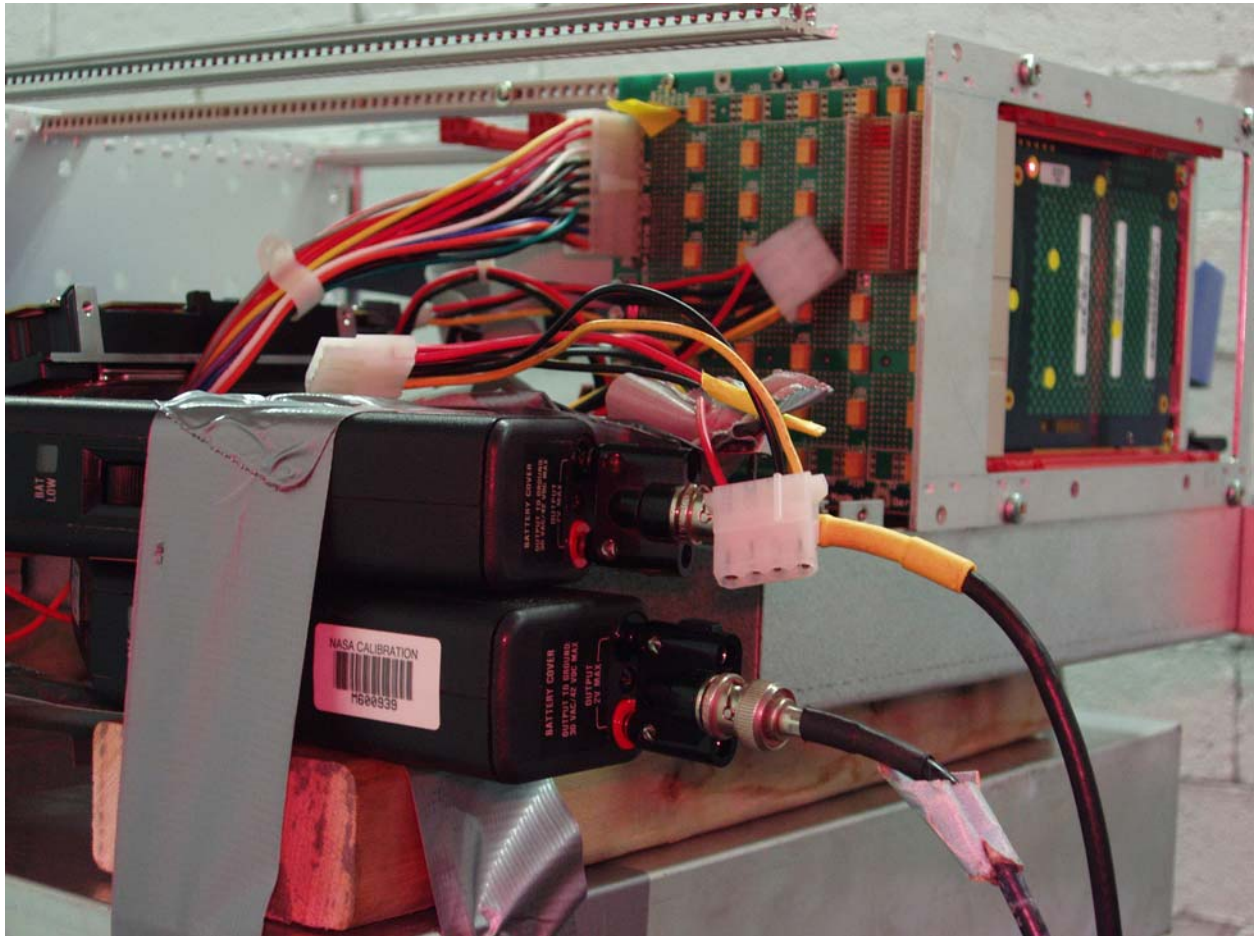
FIGURE 7. VMIC VMIPC-5790 Ultra 160 SCSI Controller

The errors that were encountered while testing the IPSU VMIC VMIPC-5790 Ultra 160 SCSI Controller produced an overall MTBF of 34.8 days. These errors consisted of functional interrupts. In most instances a recycling of power to the SCSI Controller was needed to correct the error.
